Emergency Repair of the Hernando de Soto Bridge

**TSITE Spring Meeting
May 18, 2022**

Interstate 40 Hernando de Soto Bridge

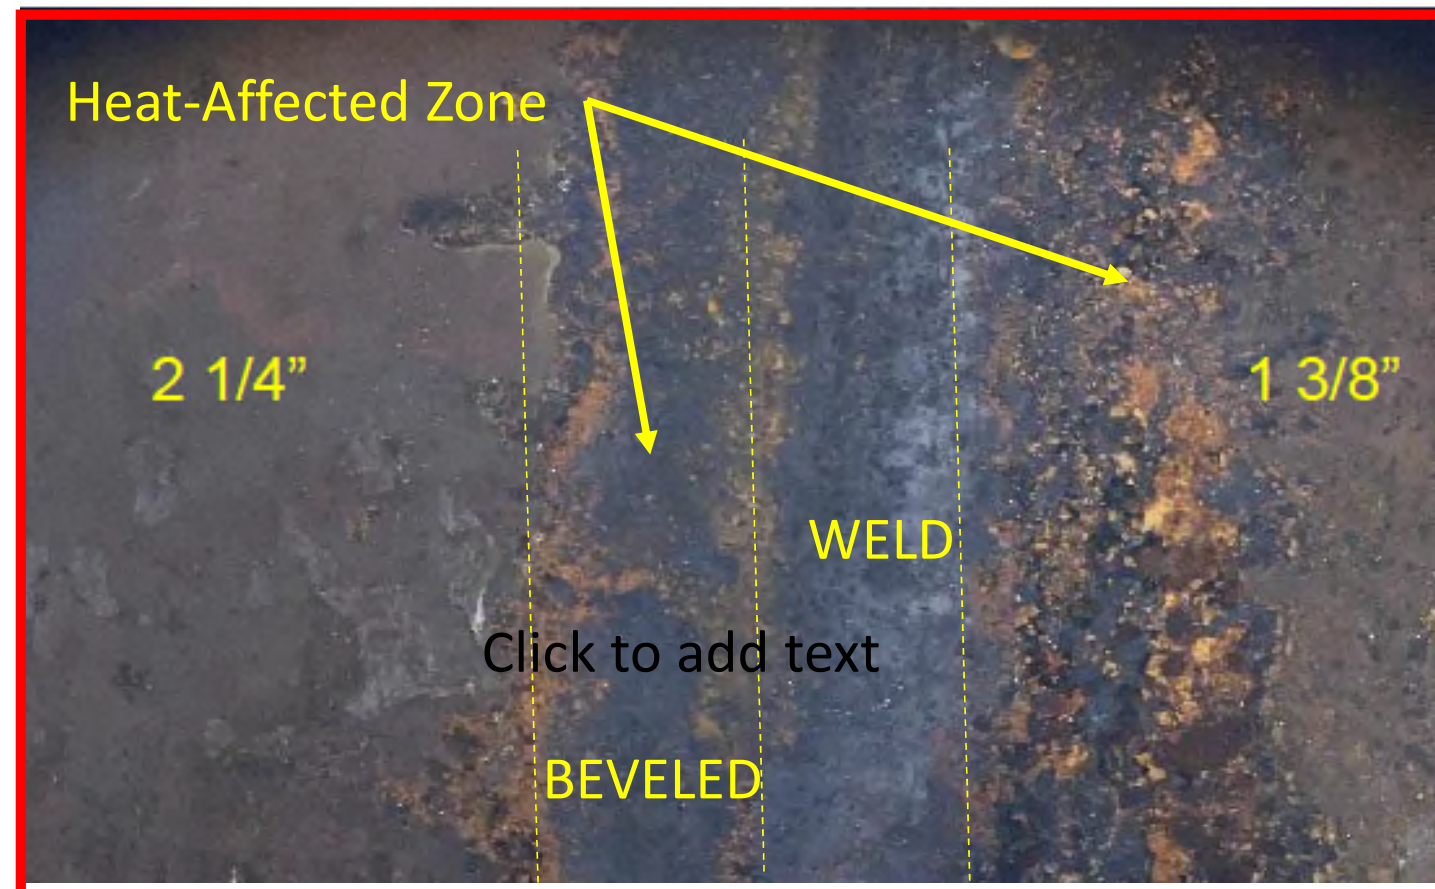
Inside Surface of Tie Girder Box Section

2 1/4" Plate

Weld

1 3/8" Plate

Outside Surface of Tie Girder Box Section

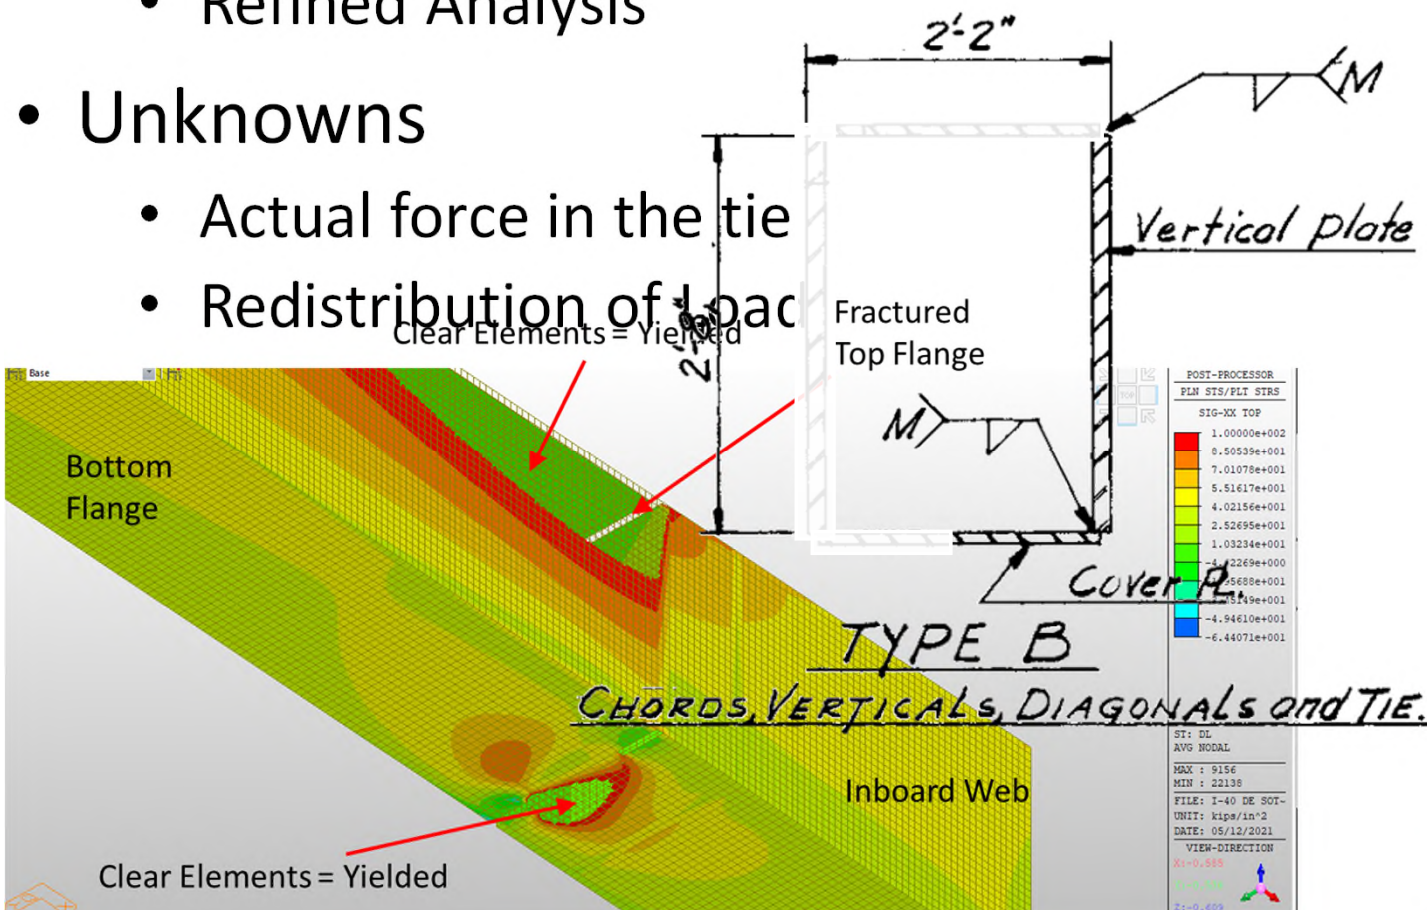
How Bad is it?

- T1 steel = 100 ksi (+)
 - P/A design = 38ksi
- Fracture 113 in² -> 51.5in² (**45%!**)
 - P/A after Fracture = 83ksi
- Eccentric Loading
 - Refined Analysis
- Unknowns
 - Actual force in the tie
 - Redistribution of Load

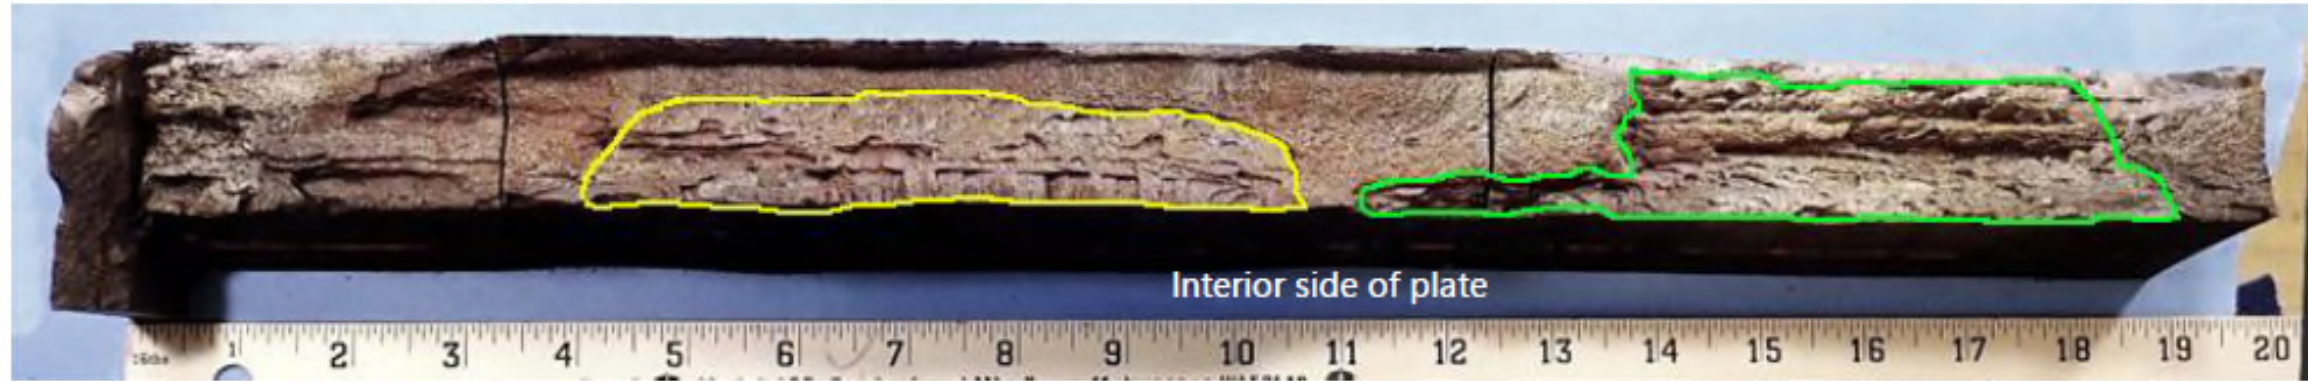
Figure 20. Lower portion of fracture showing Primary Preexisting Crack Region (yellow) and the Secondary Preexisting Crack Region (green).

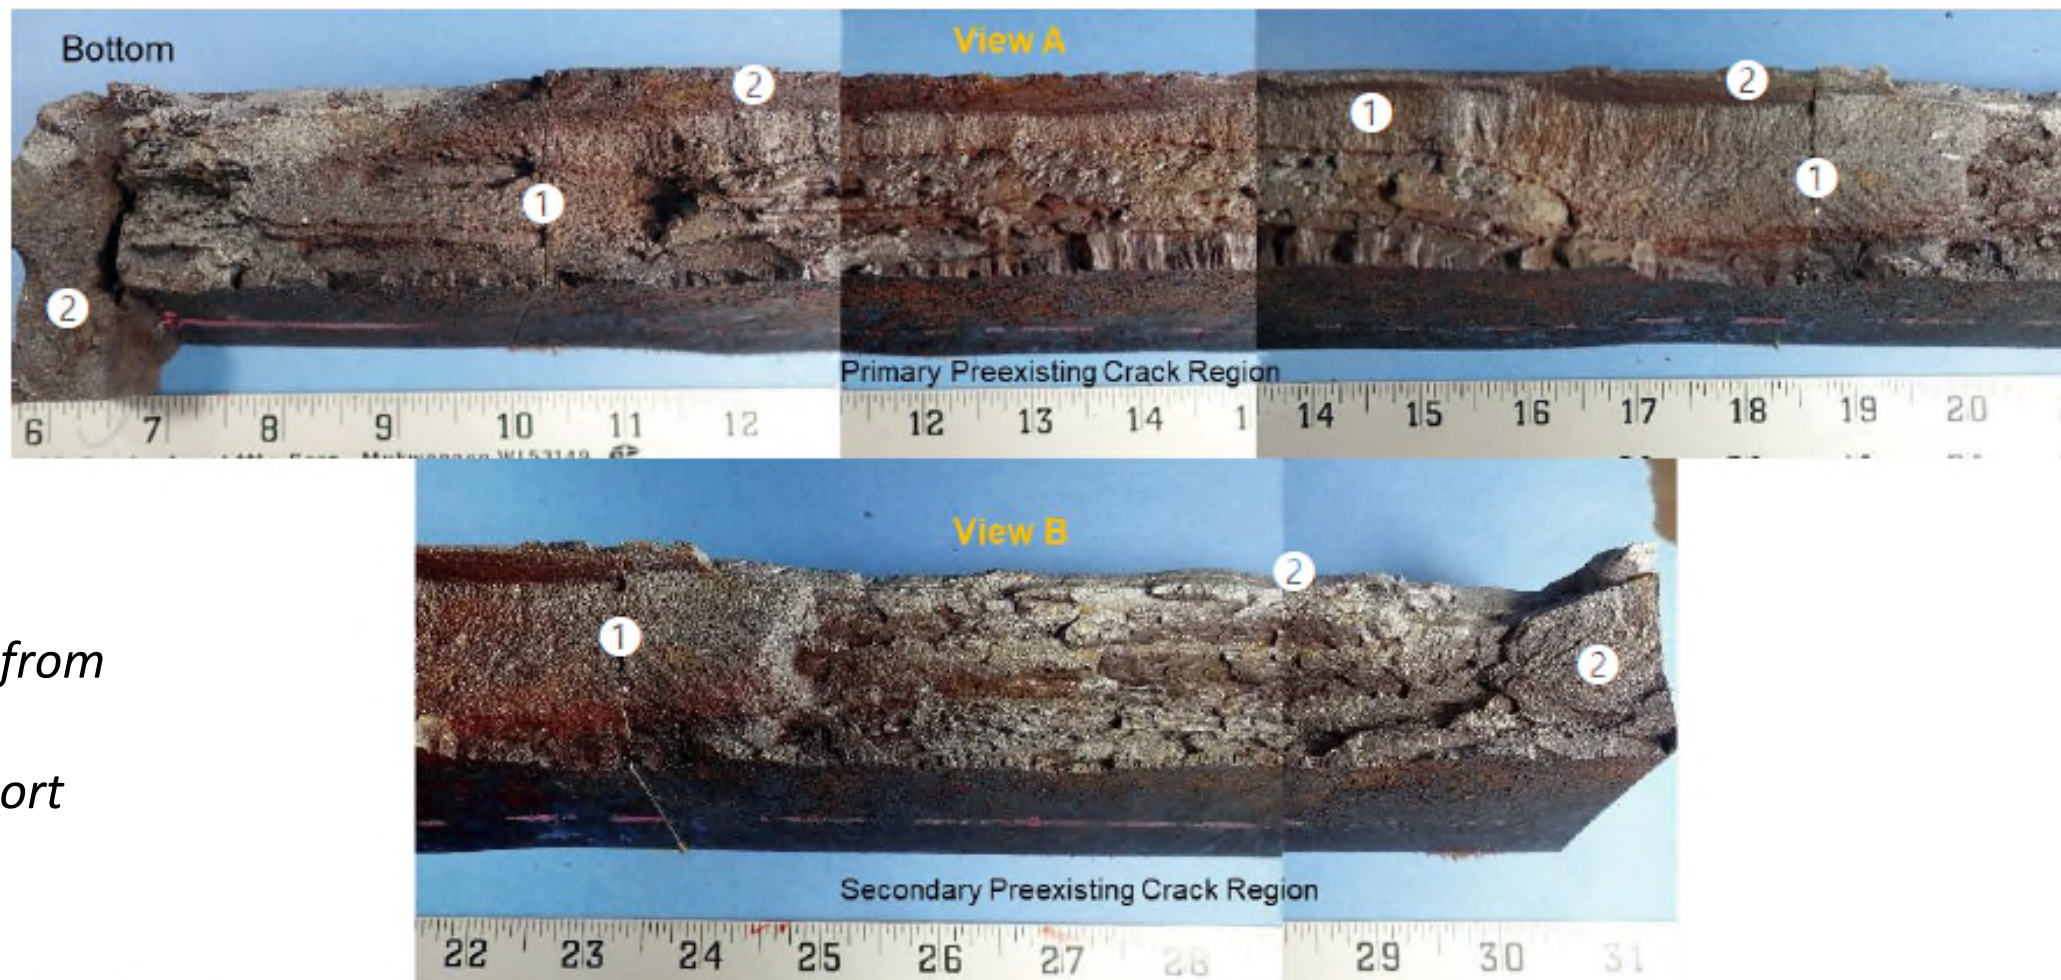
Figure 21. Higher magnification of the two preexisting crack regions after cleaning (1 first fracture and 2 second fracture).

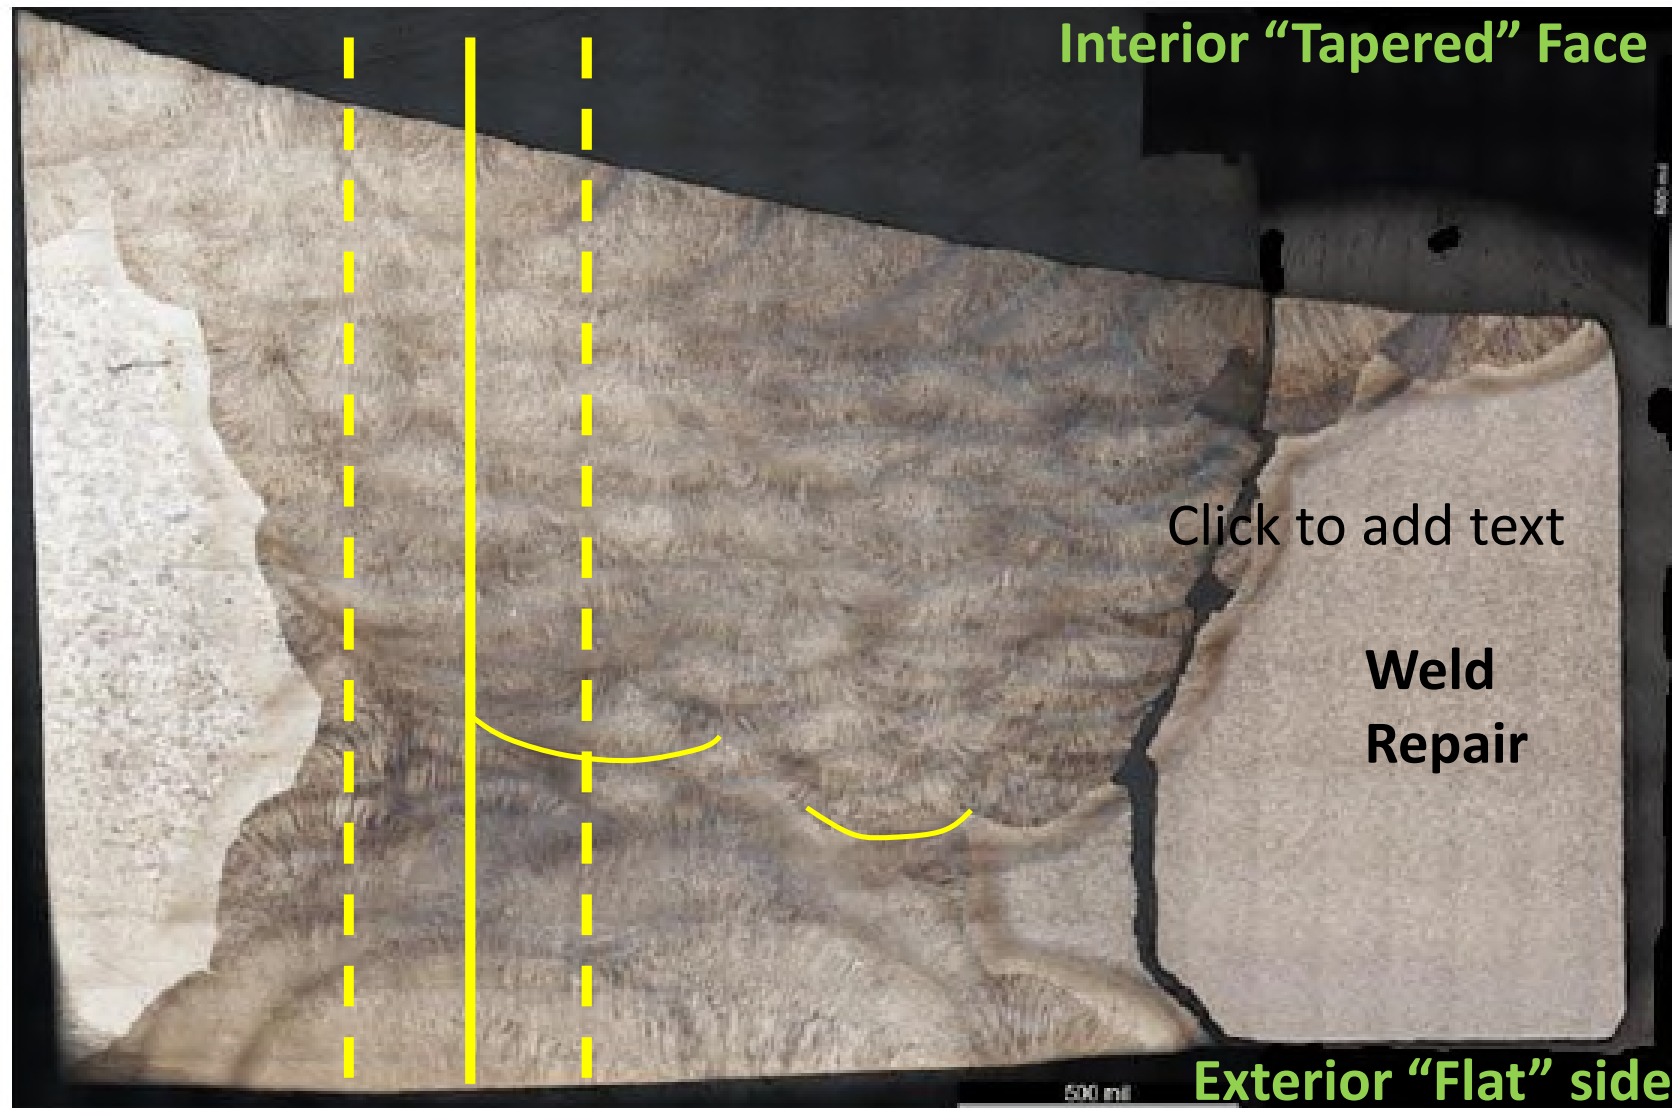
Figure 39. Primary preexisting crack weld profile.

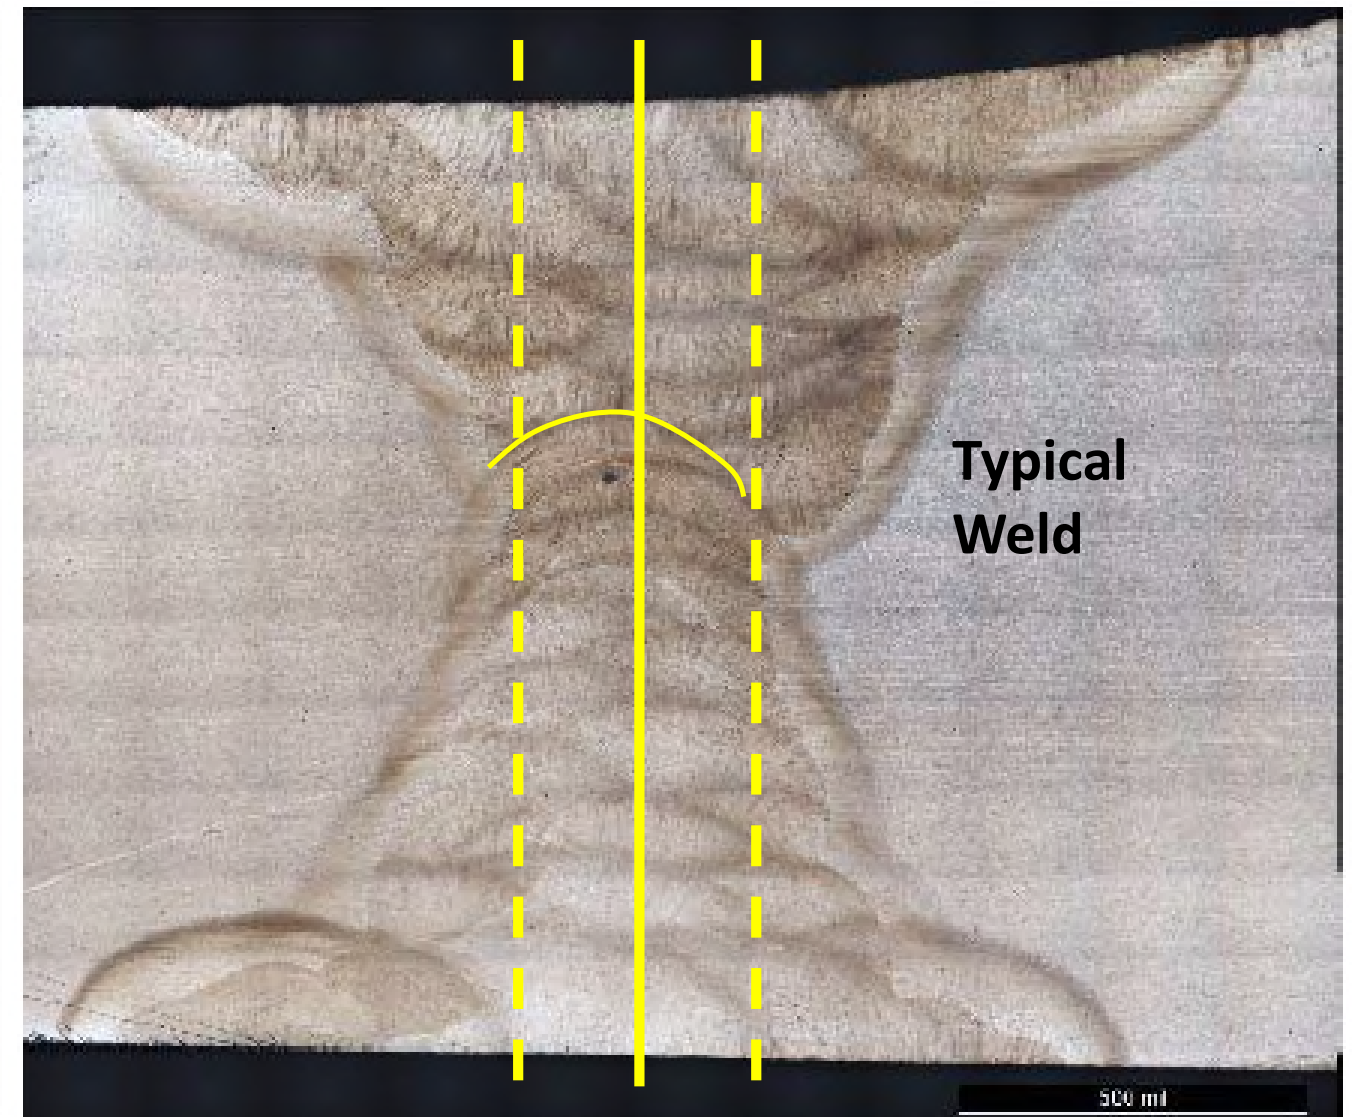
Figure 40. Core Sample SA008E weld profile.

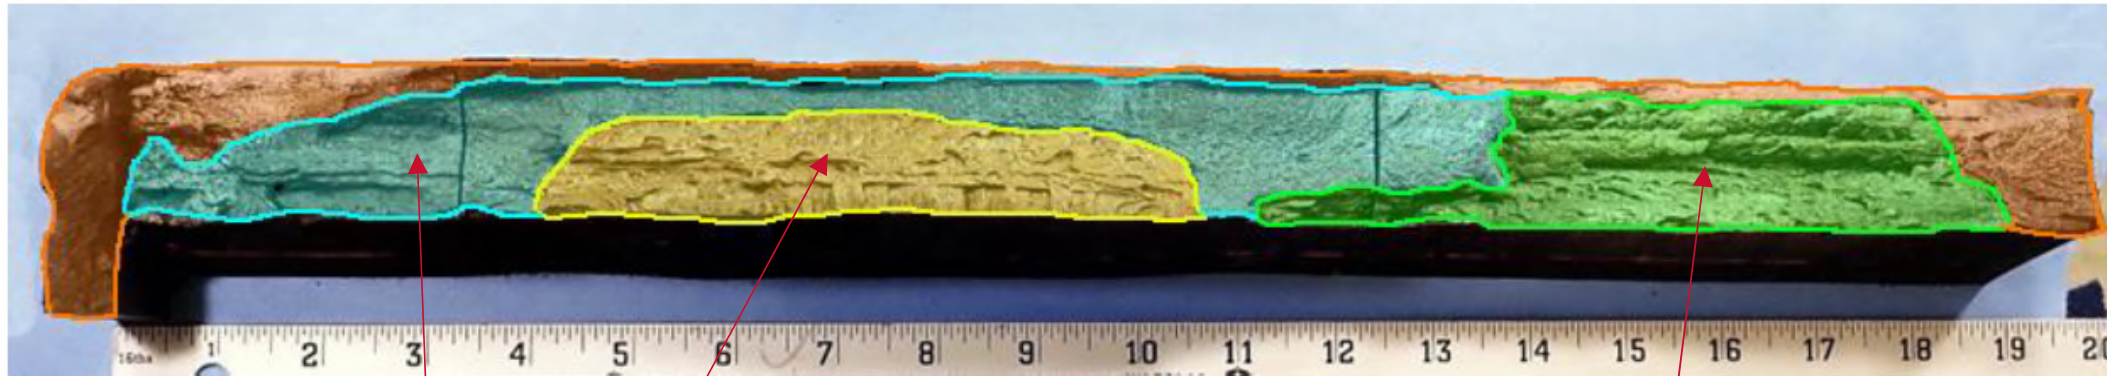
Figure 61. Lower portion of fracture, color-coded to indicate failure sequence.

Fracture Event #1

Secondary Pre-existing Crack

Primary Pre-existing Crack

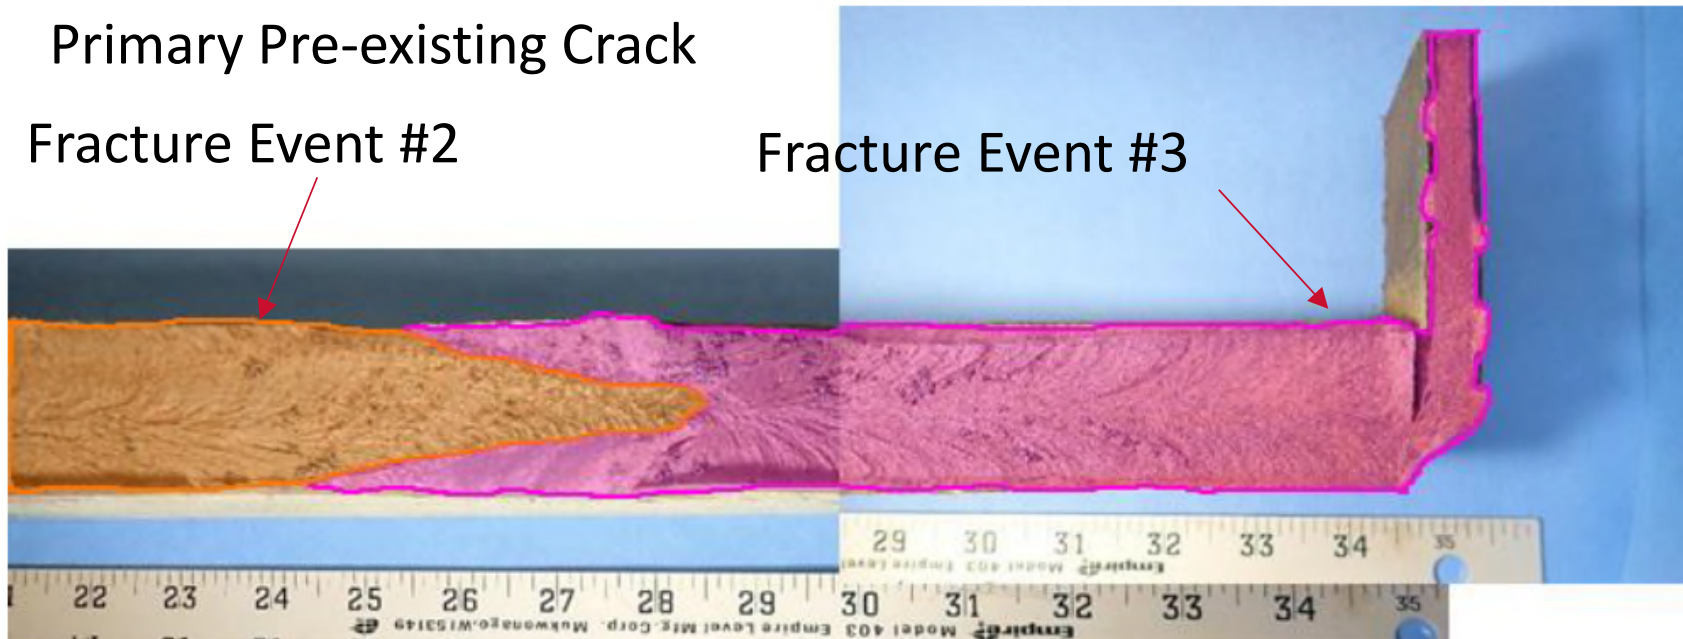
Fracture Event #2

Fracture Event #3

Figure 62. Upper portion of fracture, color-coded to indicate failure sequence.
