Emergency Repair of the Hernando de Soto Bridge

**TSITE Spring Meeting
May 18, 2022**

Interstate 40 Hernando de Soto Bridge

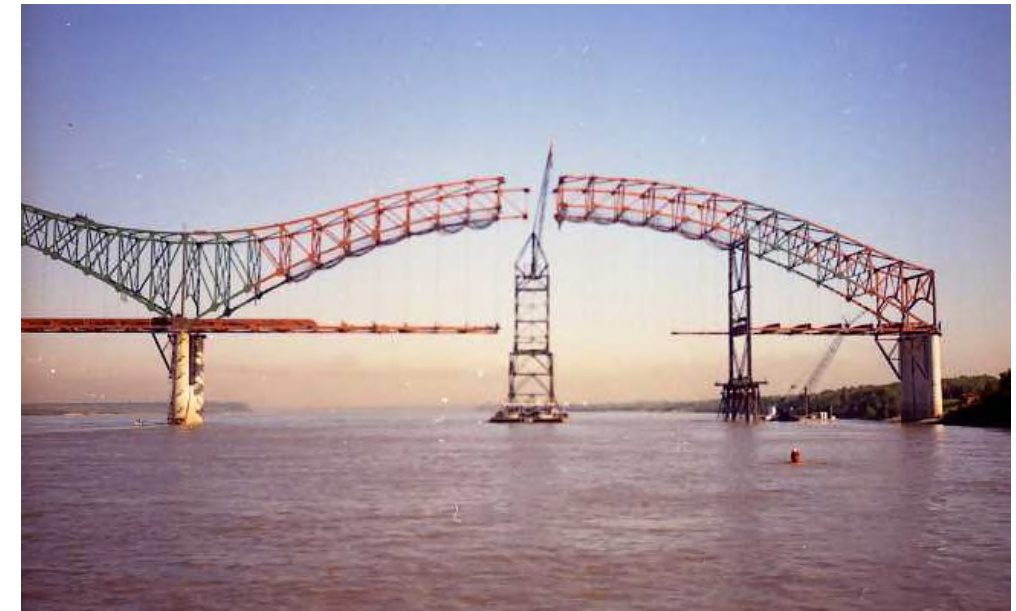
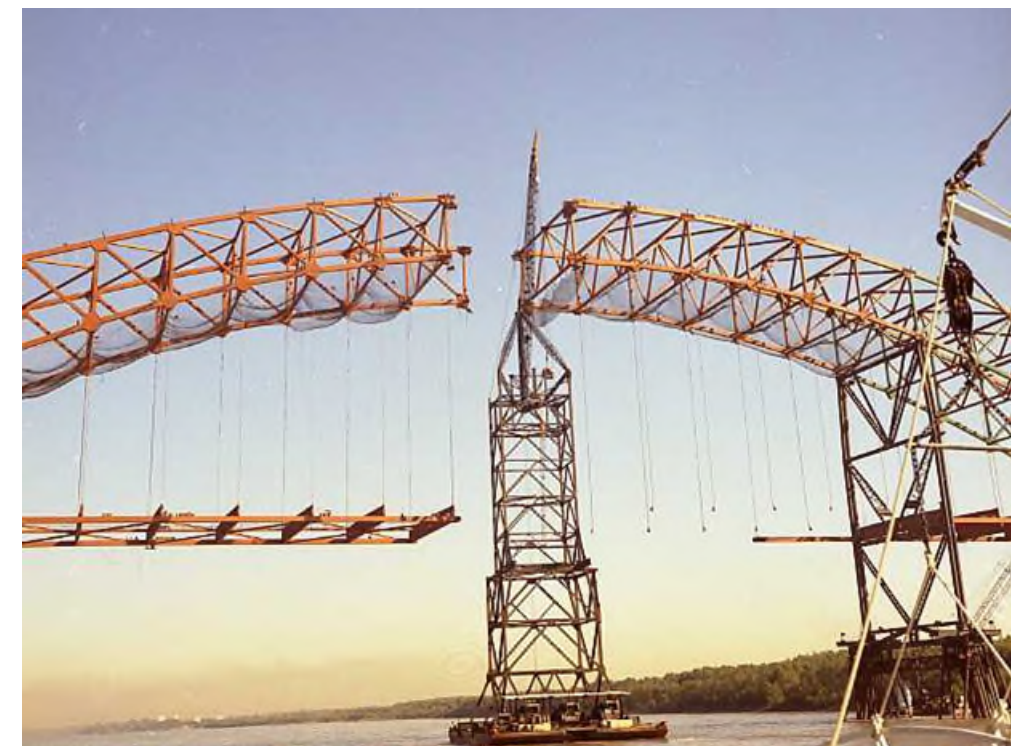
Propagation of Fracture

- TDOT did not ask for recommendations on safety/risk.
- MBI provides FEA model results to TDOT
 - TDOT does a risk assessment using model data, historic photos & former staff
 - Construction photos suggest favorable sequence of loading during construction
 - **TDOT provides risk evaluation to USCG who opens river to traffic.**

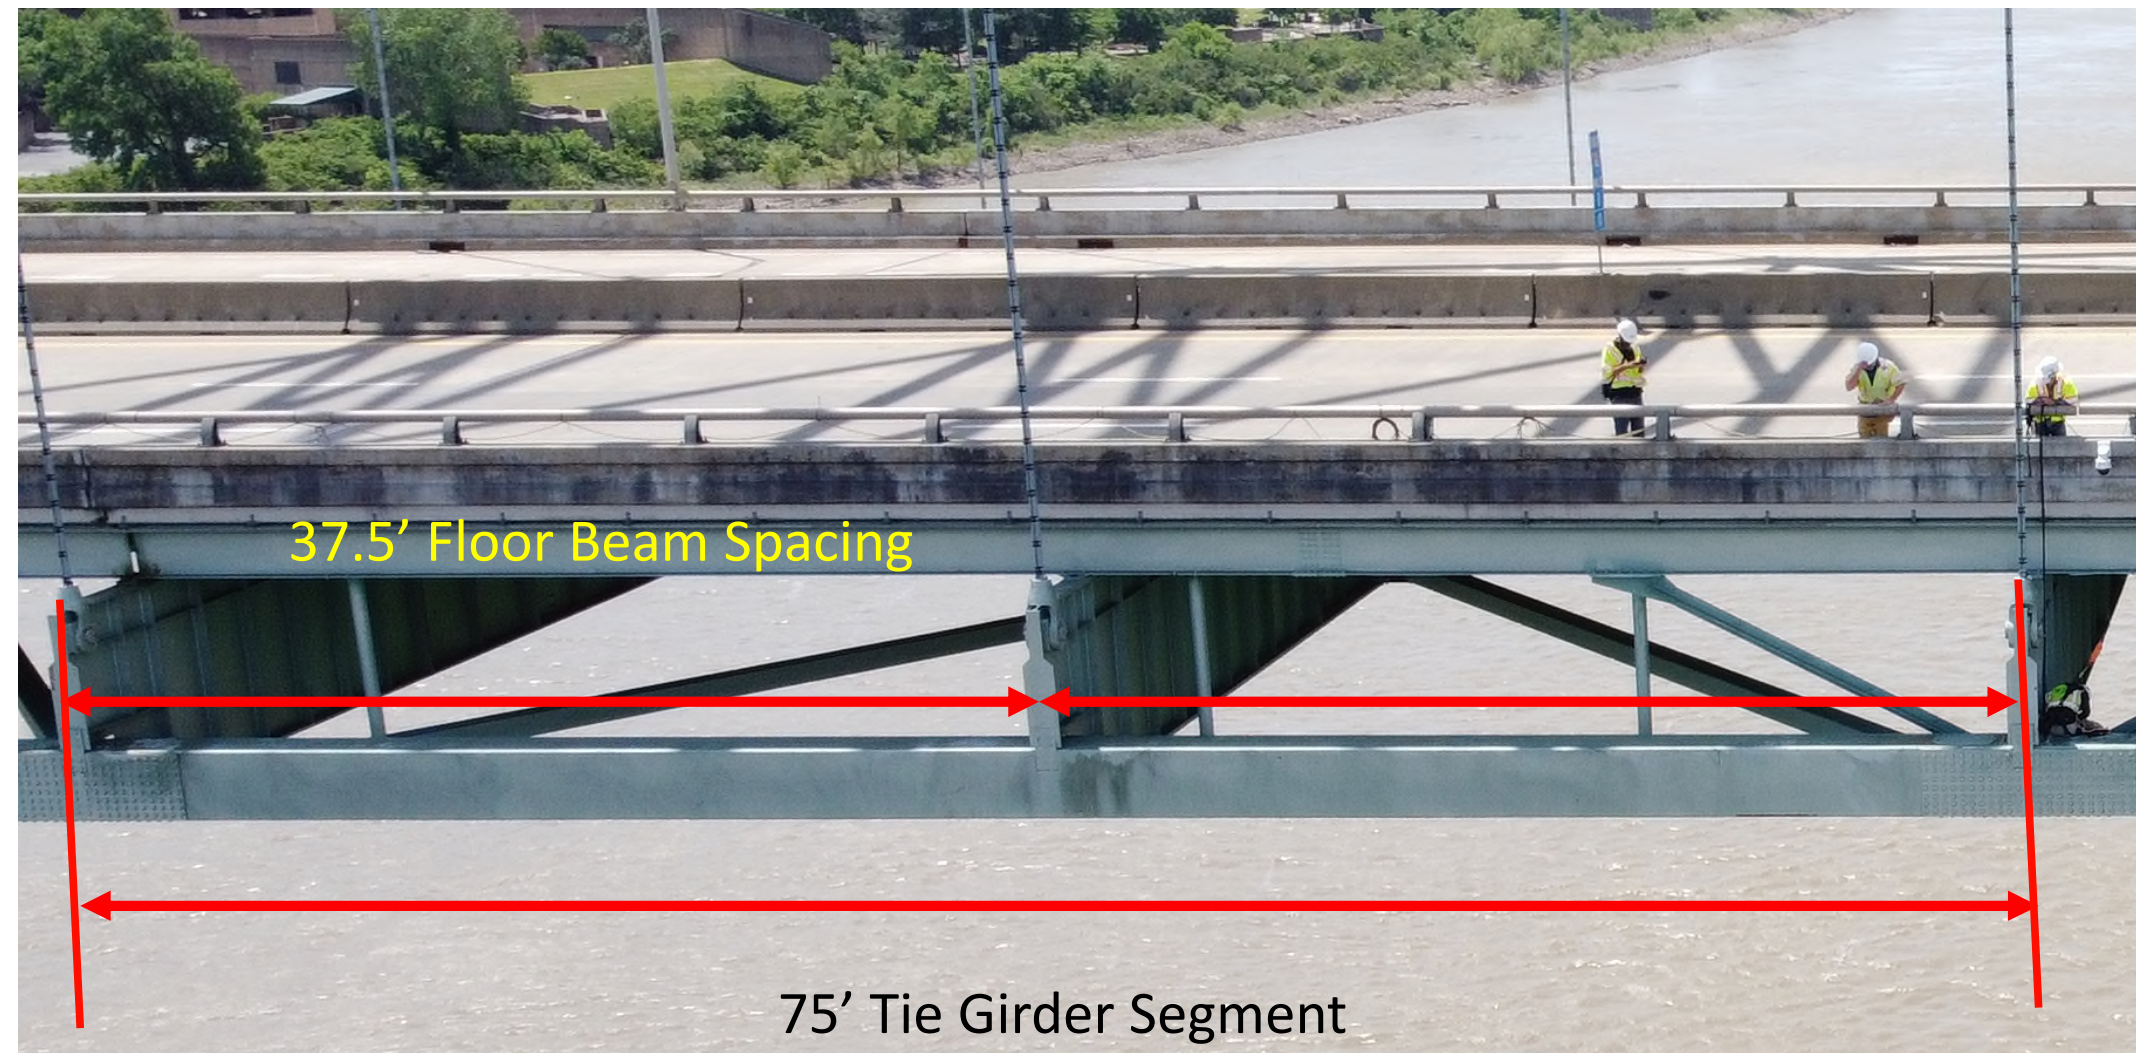
- Design Challenges for Phase 1 –
 - 100 ksi plate in tie girder and select high truss members
 - Thin (1.375") plate sections limited bolting options due to net section limitations
 - Geometry (twist) of current tie girder impacted plating design

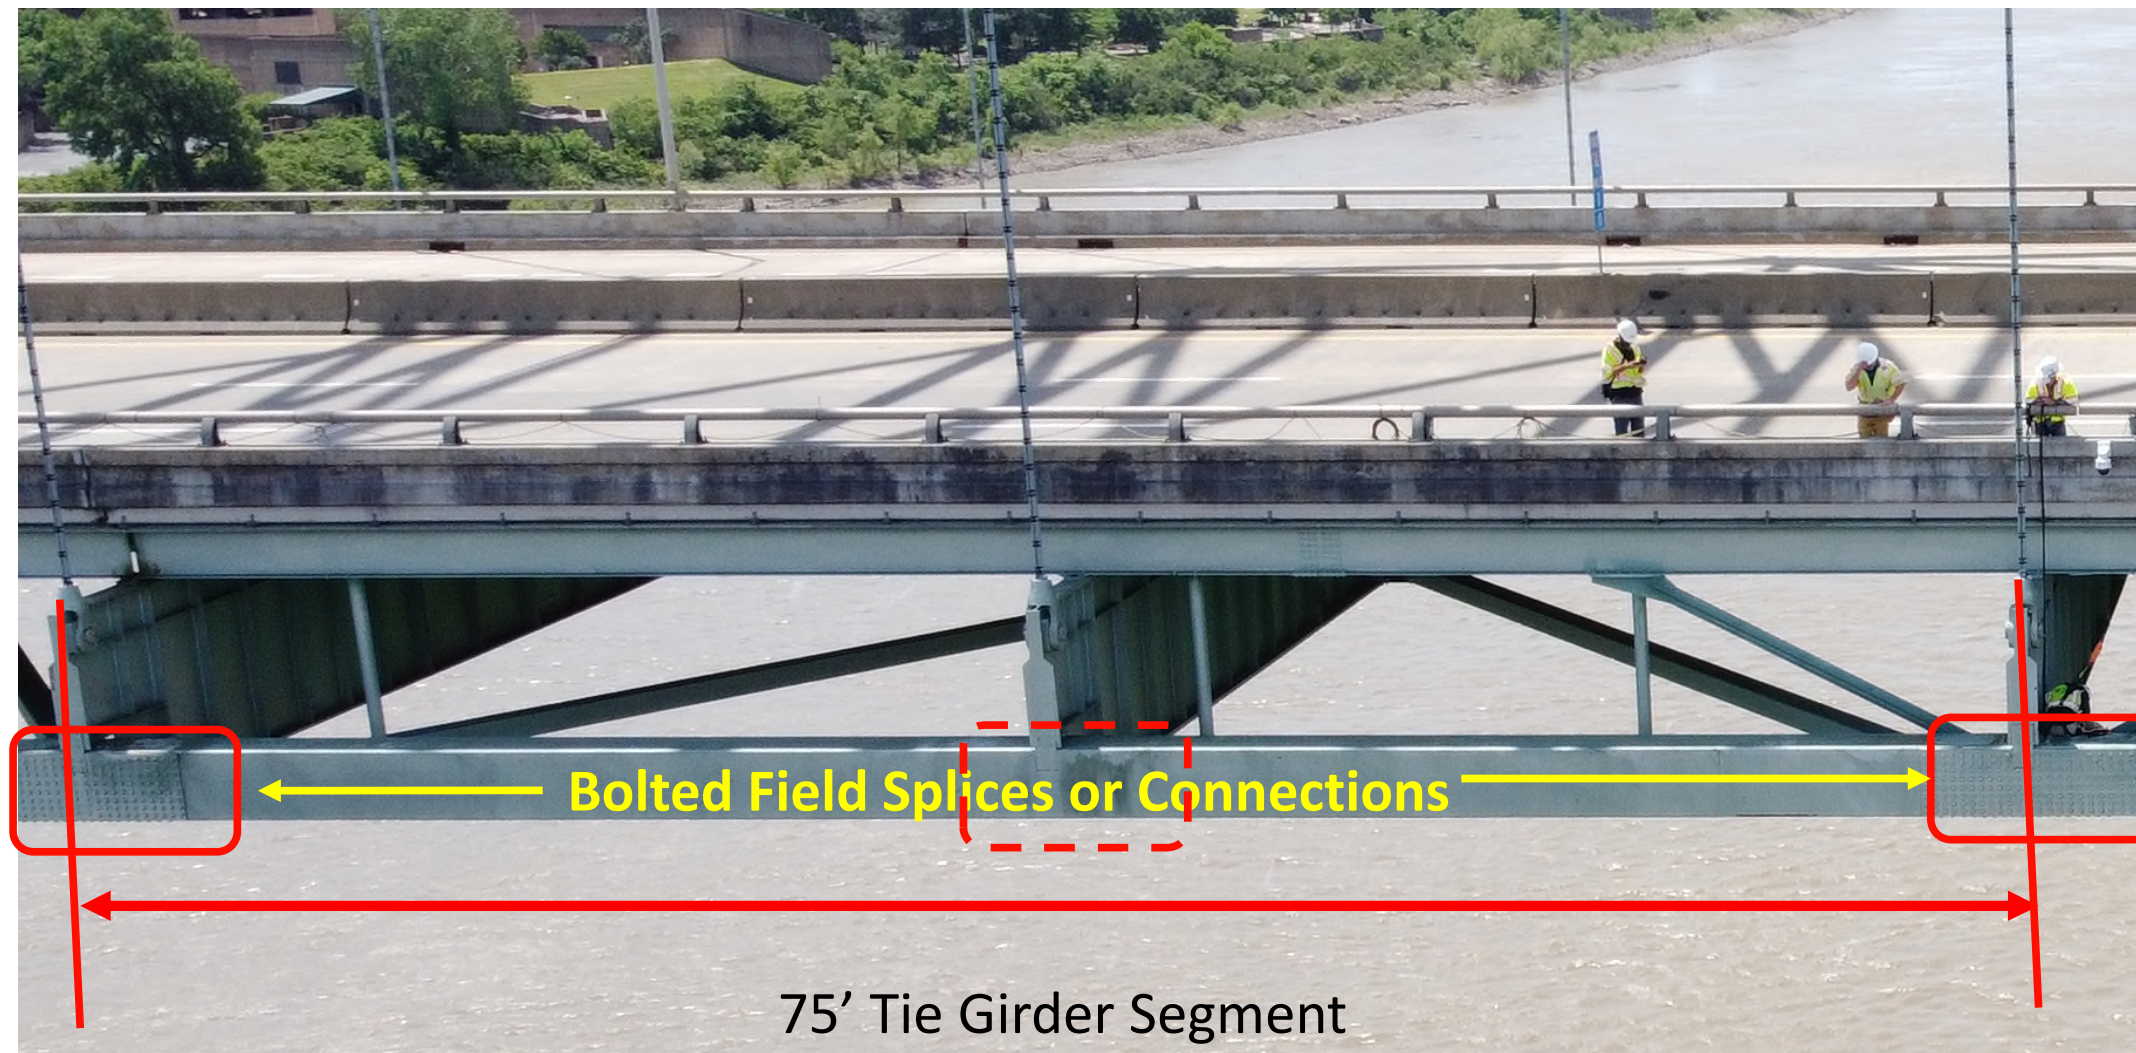
- Design Challenges for Phase 1 –
 - 100 ksi plate in tie girder and select high truss members
 - Thin (1.375") plate sections limited bolting options due to net section limitations
 - Geometry (twist) of current tie girder impacted plating design

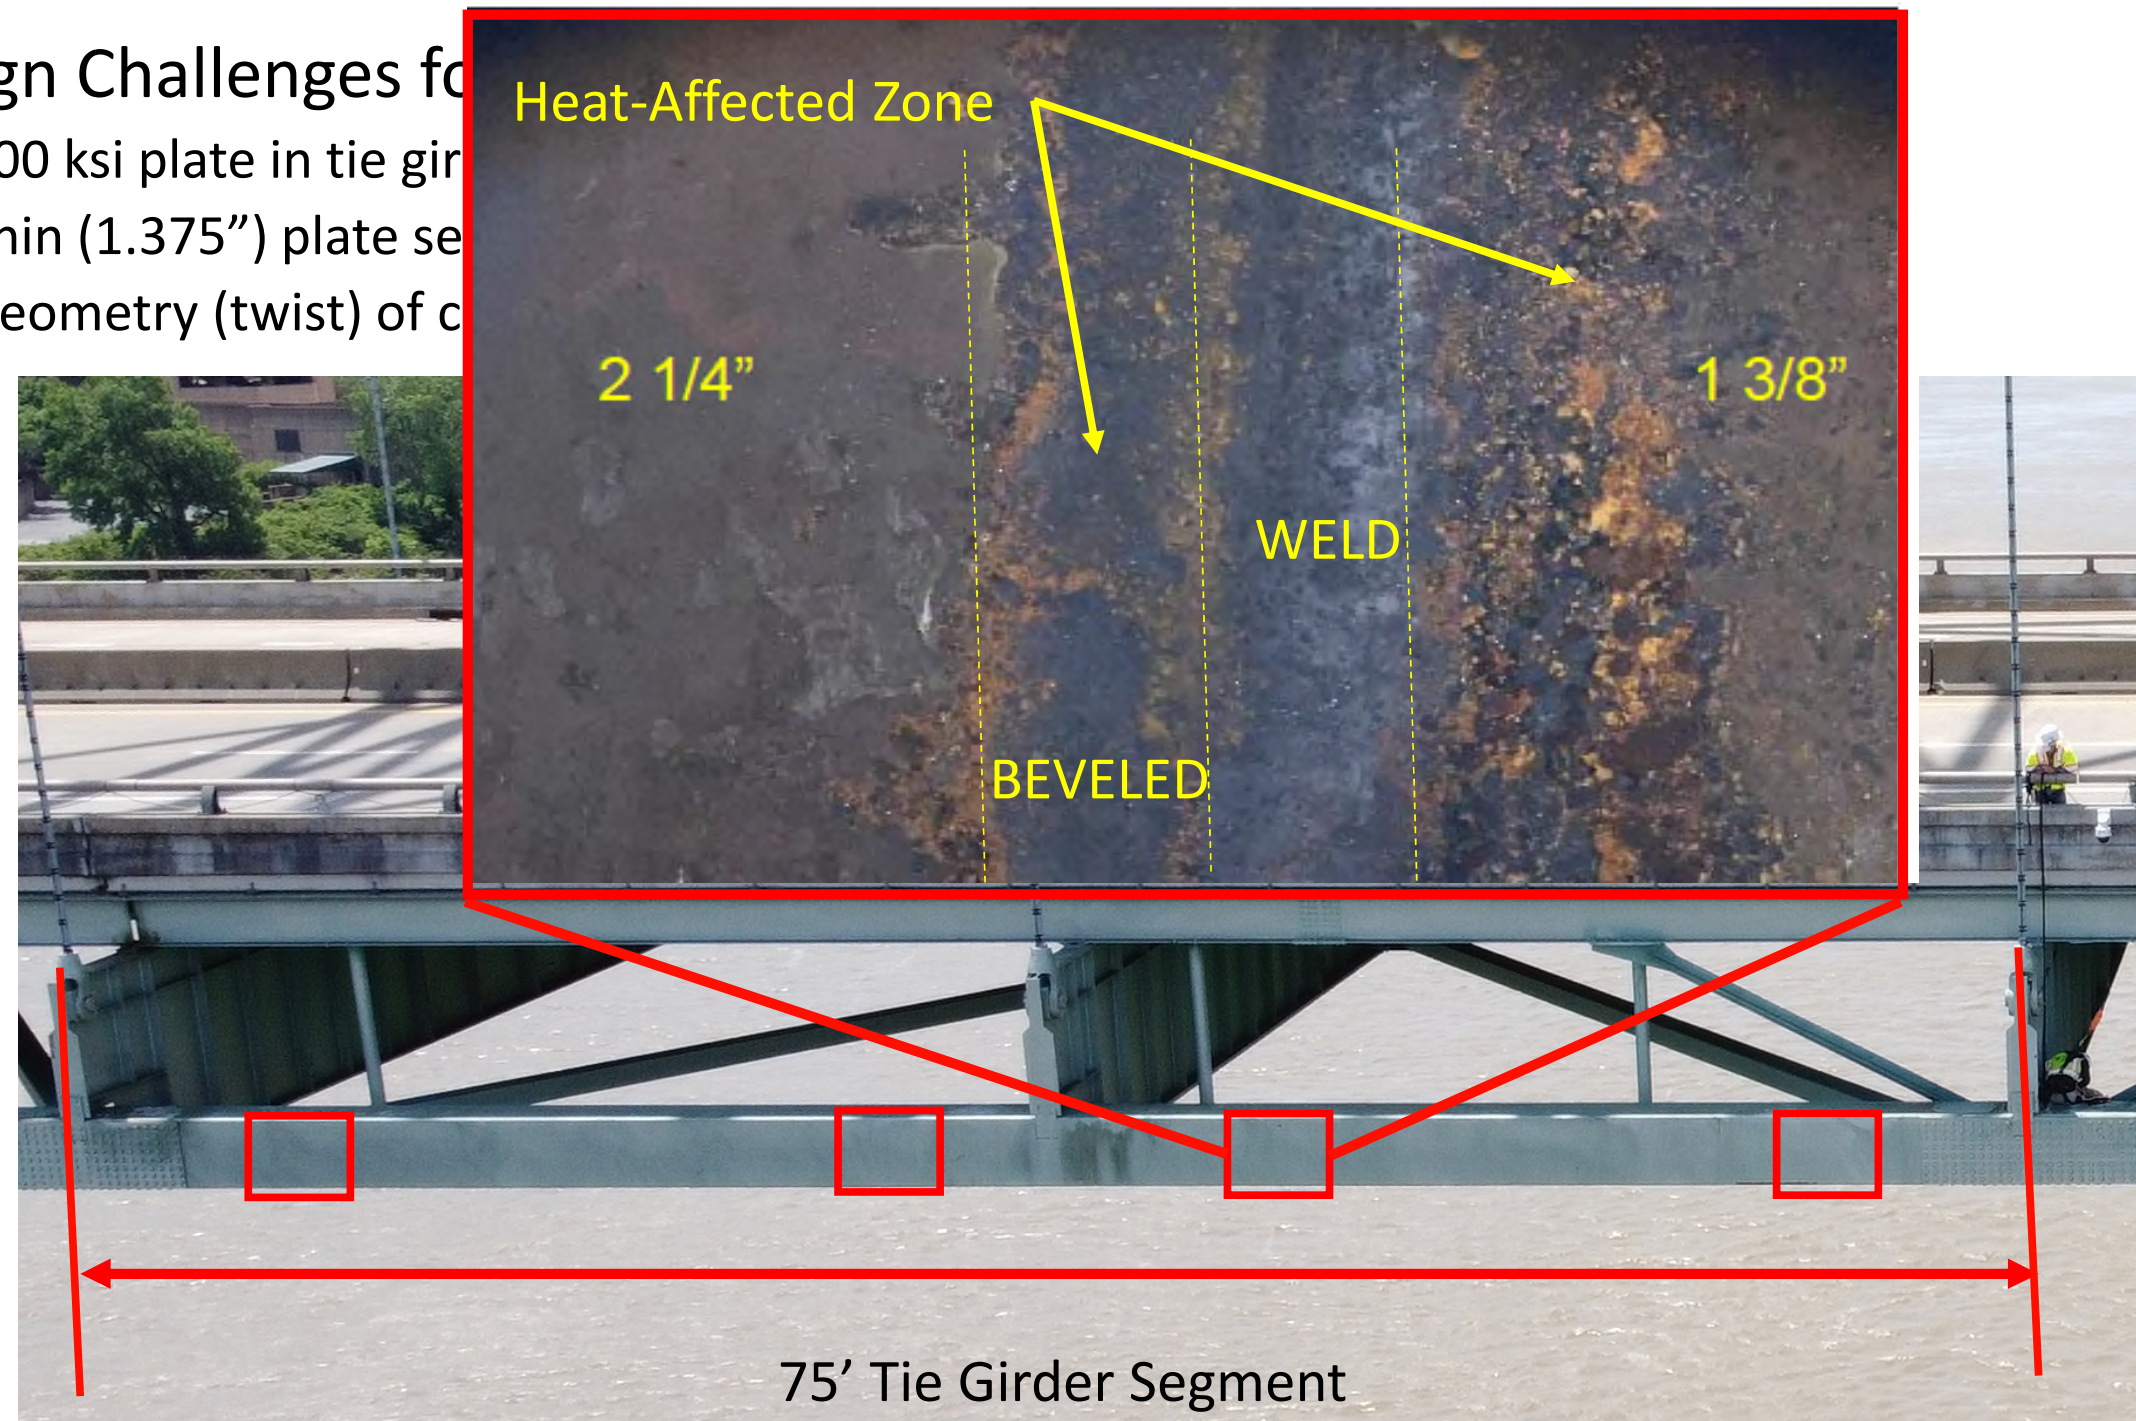
- Design Challenges for
– 100 ksi plate in tie girder
– Thin (1.375") plate section
– Geometry (twist) of connection

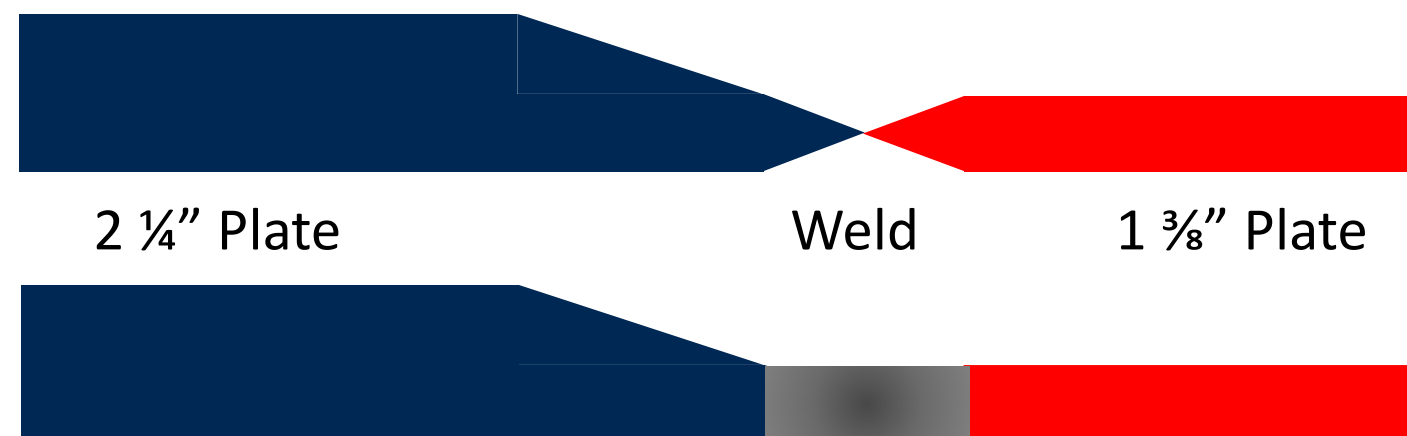
Inside Surface of Tie Girder Box Section

2 1/4" Plate

Weld

1 3/8" Plate

Outside Surface of Tie Girder Box Section

How Bad is it?

- T1 steel = 100 ksi (+)
 - P/A design = 38ksi
- Fracture 113 in² -> 51.5in² (**45%!**)
 - P/A after Fracture = 83ksi
- Eccentric Loading
 - Refined Analysis
- Unknowns
 - Actual force in the tie
 - Redistribution of Load

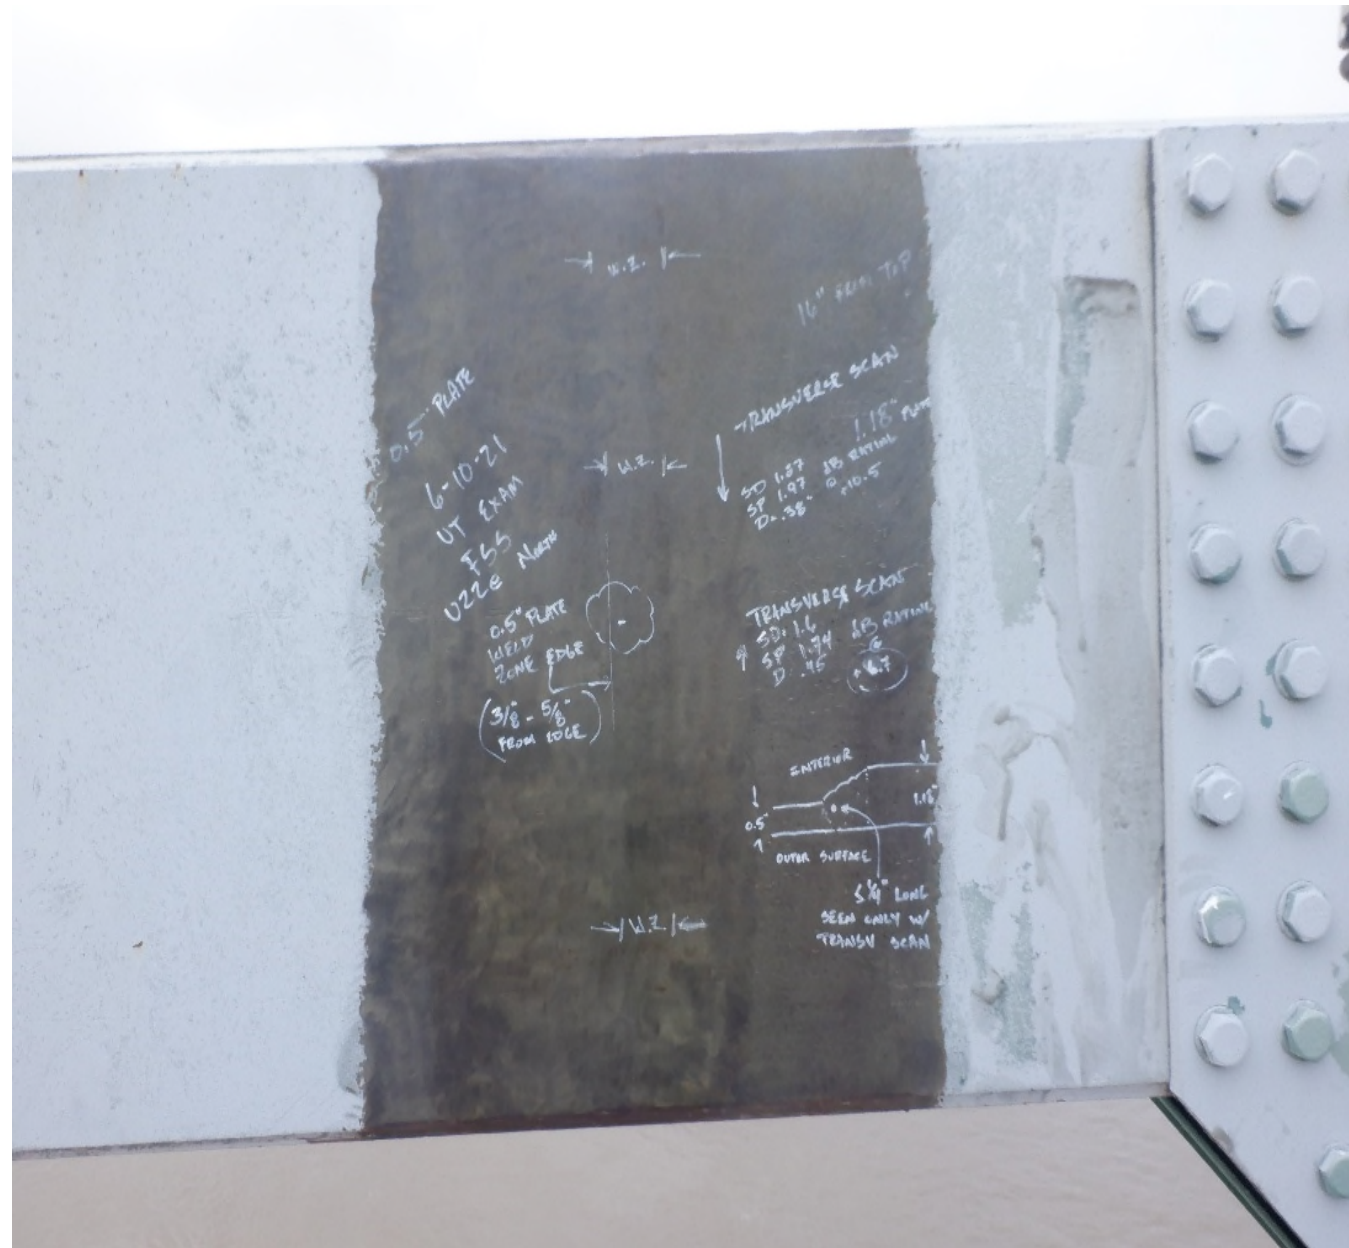
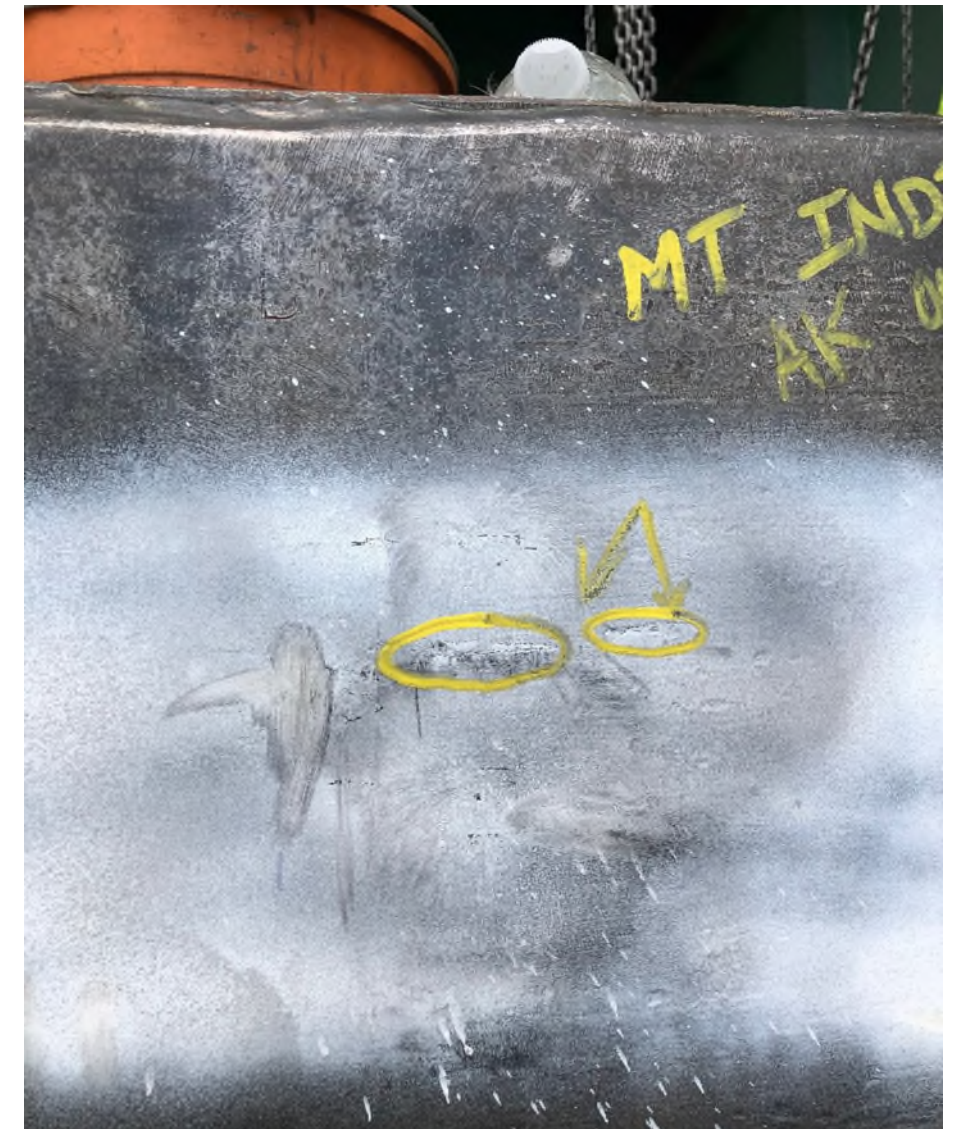
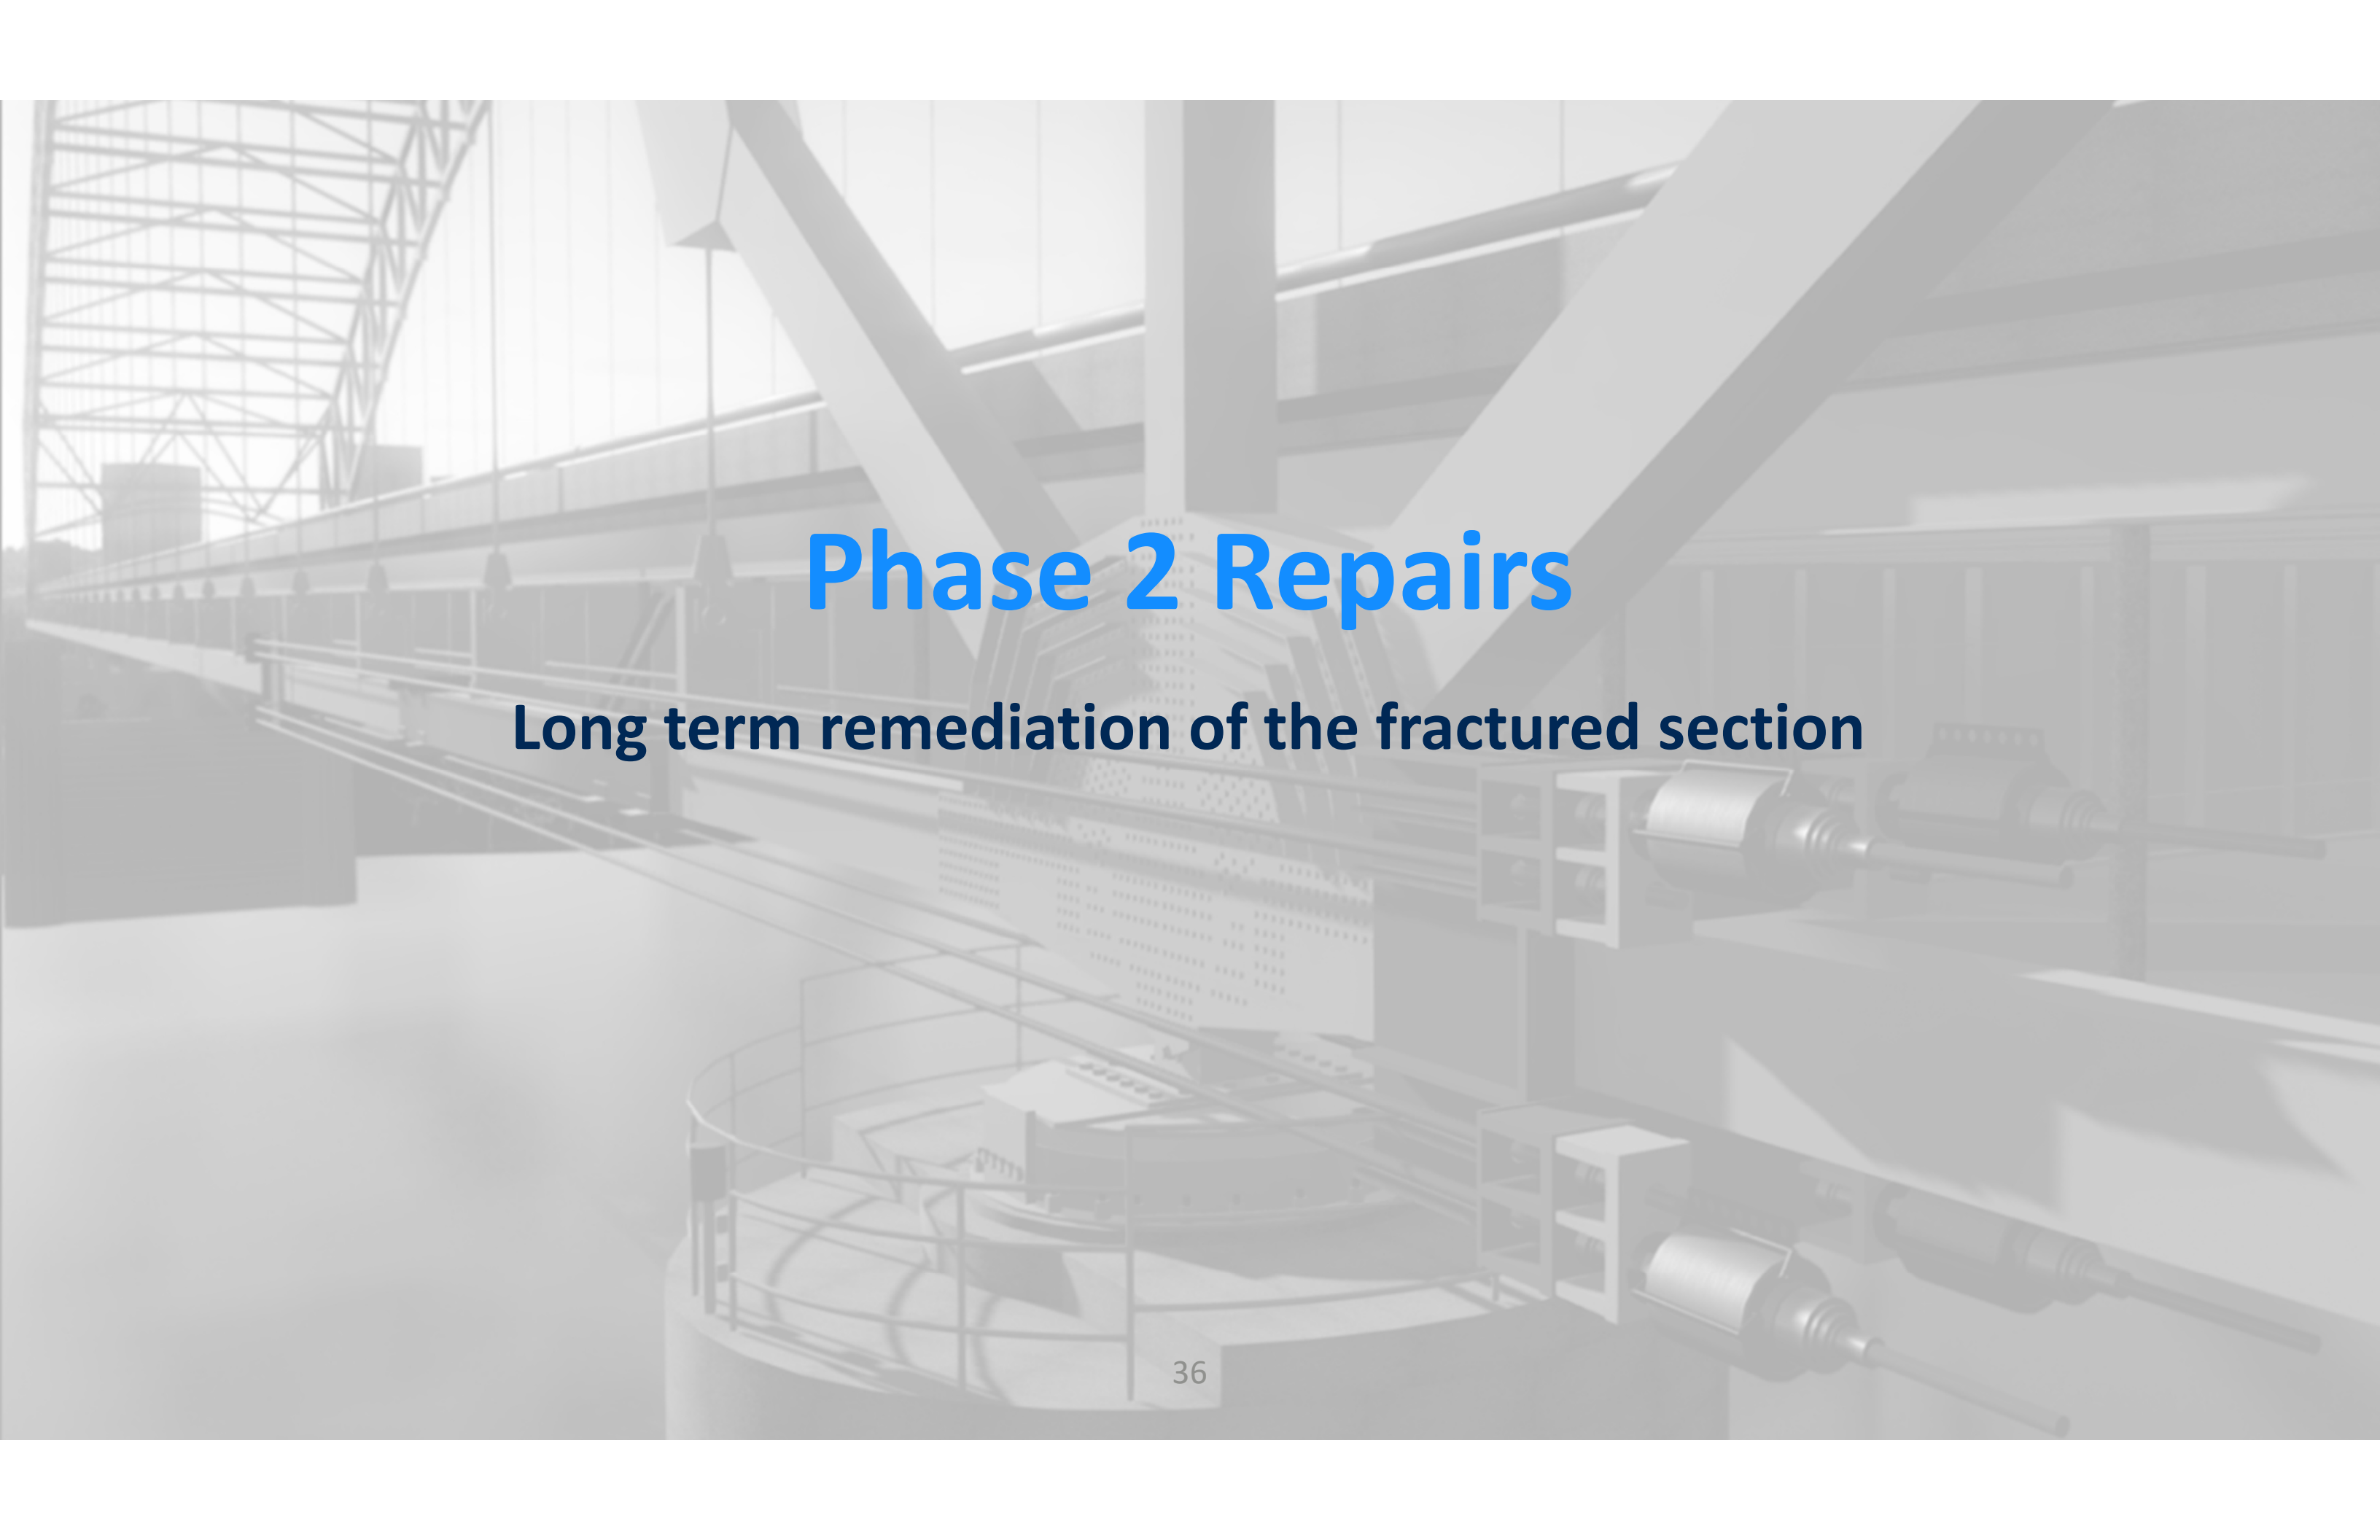
- 484 tie girder weld locations + statistical sample of welds on high truss.
- Phased Array and single beam UT were used – required paint removal.
- More details later

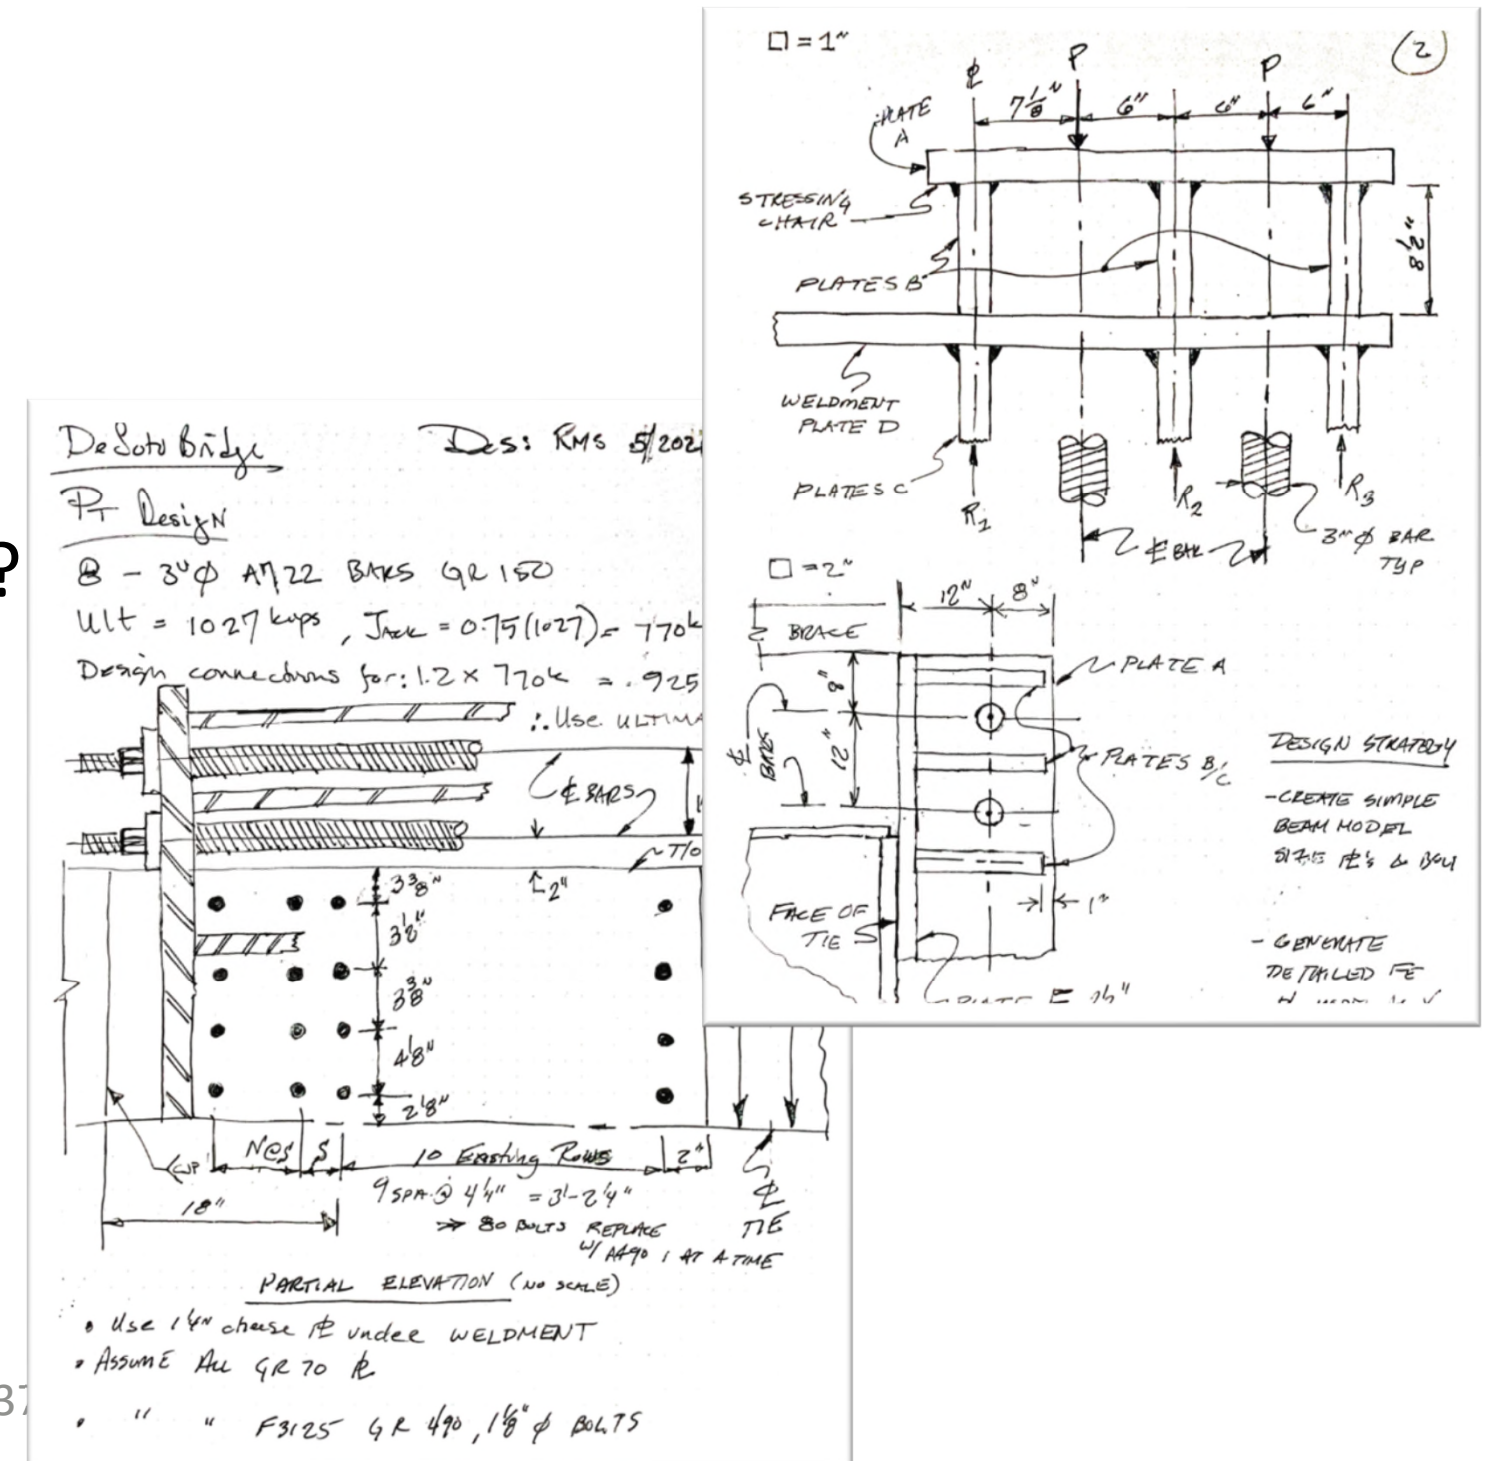
- Preserve capacity of original tie
- How much post-tensioning ?
- How much of the gap do we need to close?
- Effects on Secondary Members?
- How effective will the Post-Tensioning actually be?

- Ultimately, load path to the tie girder dictated design

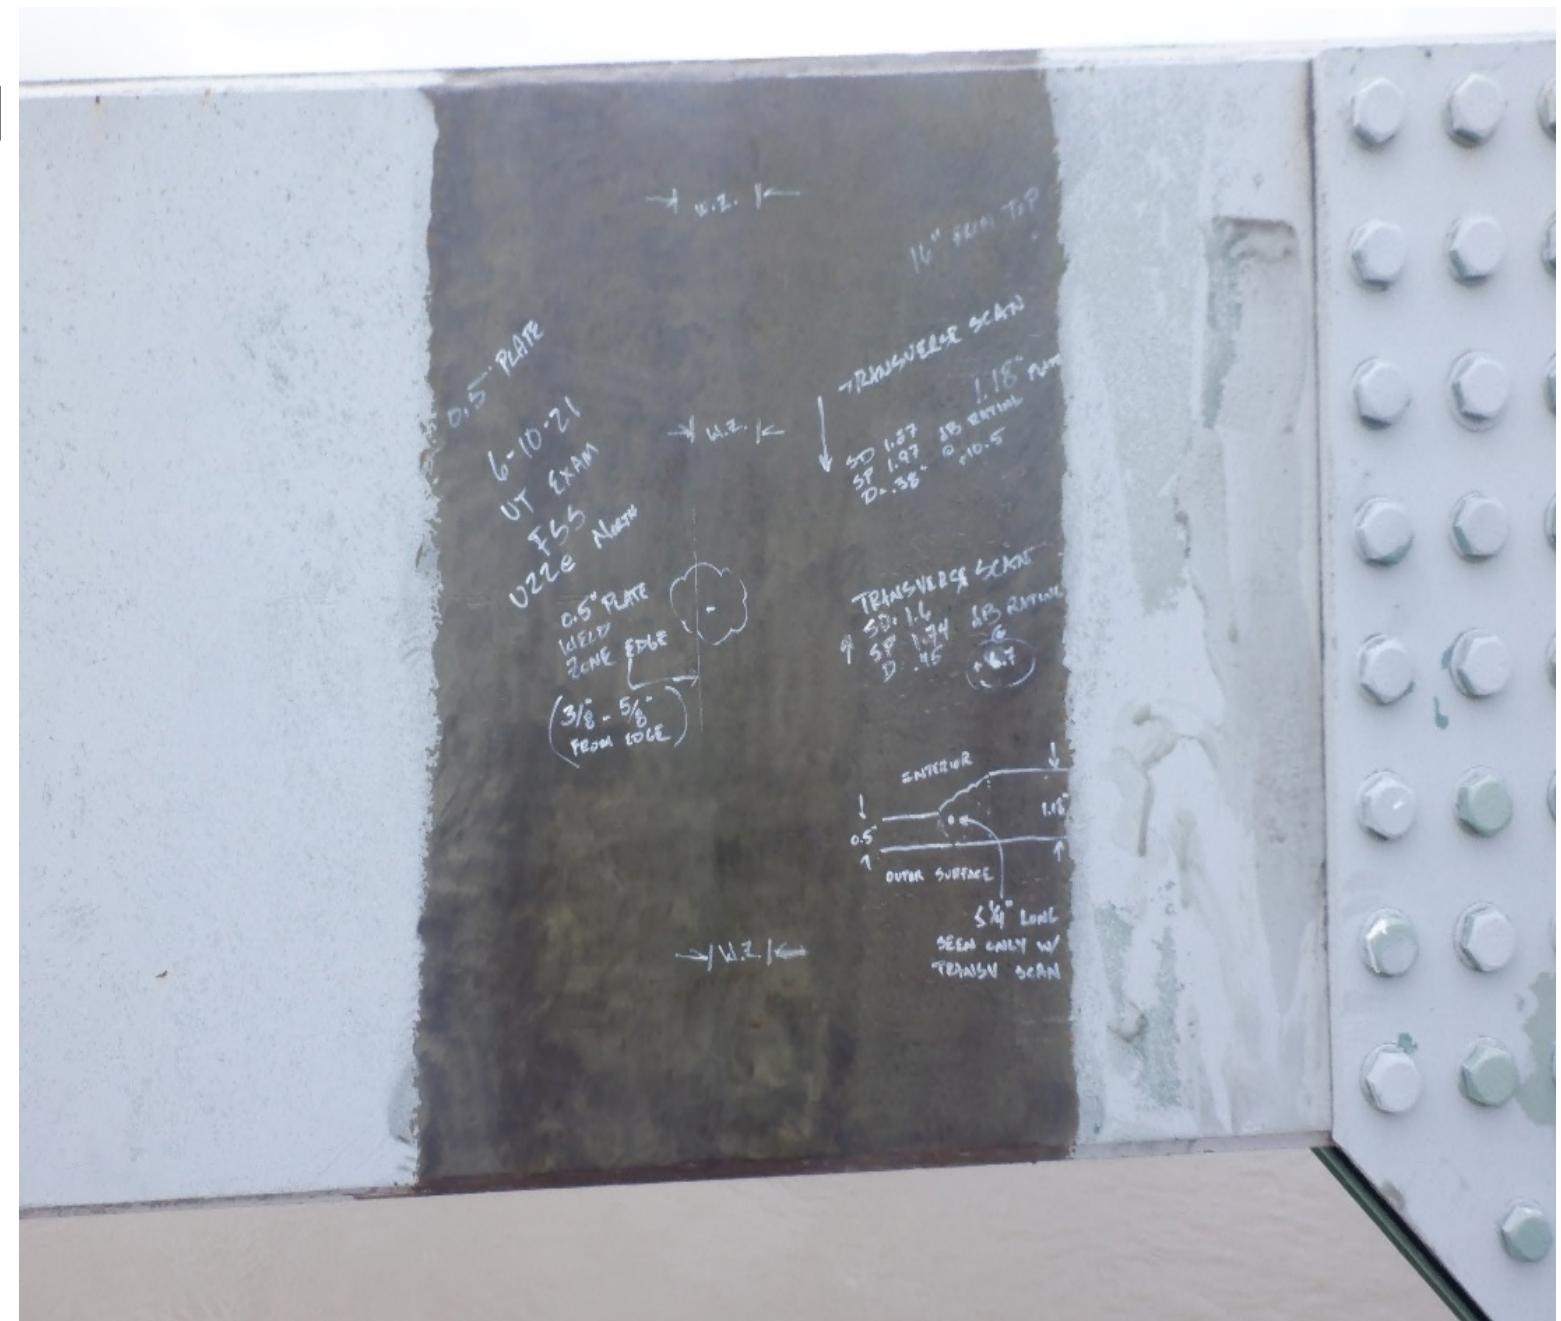
NDT Inspection of Arch Rib Member

- Full Penetration Butt Weld detail typical throughout structure
 - Potential for similar defects
 - Prevent future failure
- Arch Tie Members and Hanger Pins (Approx. 500 welds)
 - HNTB contracted CAN-USA
 - June 1st to June 23rd
- Arch Truss Members (Sampling)
 - MBI contracted Fickett
 - June 7th to June 11th and June 23rd to 25th

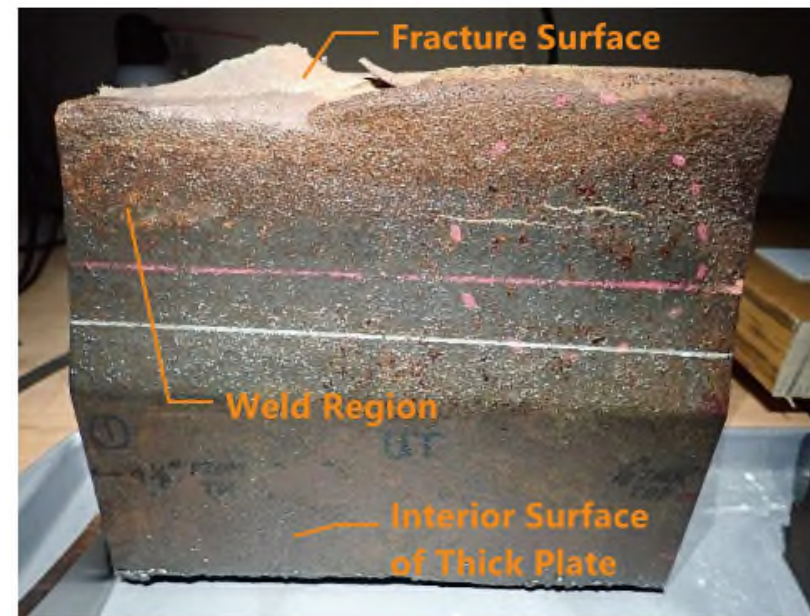
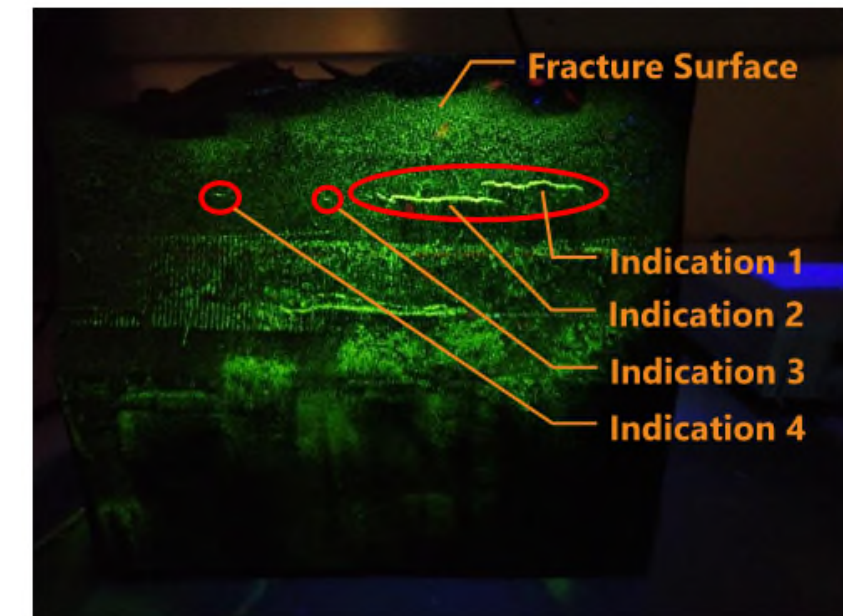
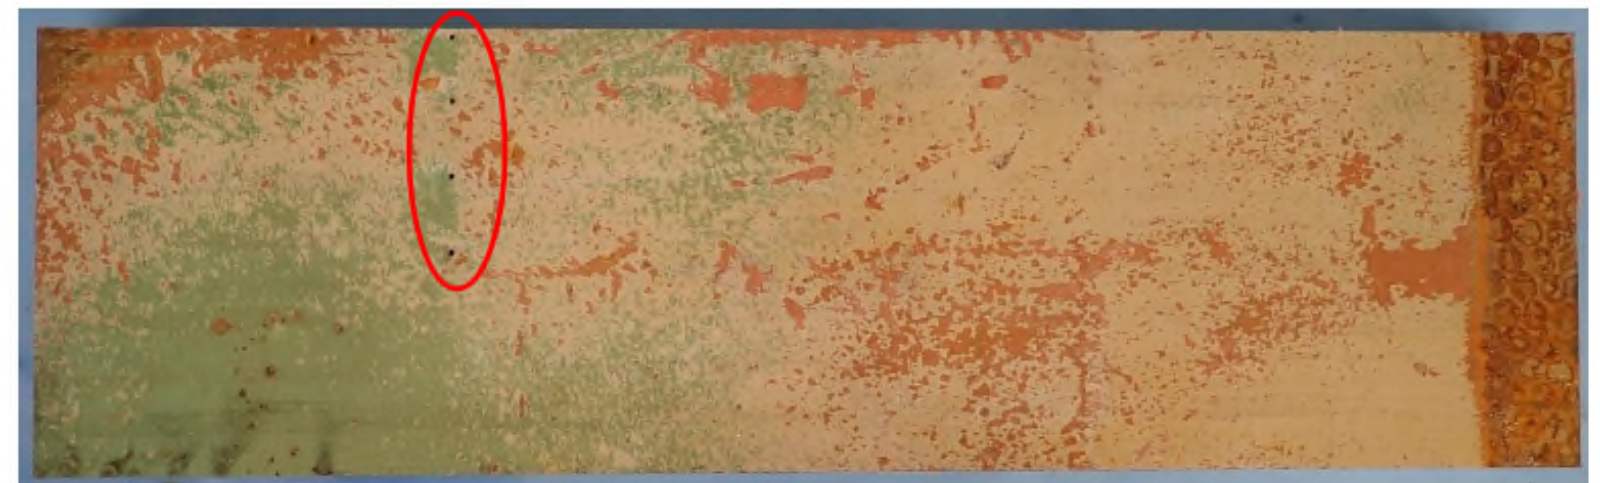
WJE Recalibration Testing
(WJE PAUT Calibration and Verification Testing Memo)

- WJE Examination of Fracture
 - Verify CAN-USA system setup sensitivity as QA/QC measure
 - Utilize confirmed defects from extracted fractured section for PAUT data reinterpretation
 - Not much data available for ASTM A514 Steel
- WJE concluded CAN-USA original setup accurate for data collection
- CAN-USA identified additional 17 rejectable welds for a grand total of 46
